# STRUCTURE EVOLUTION OF TUNGSTEN COATINGS EXPOSED TO PLASMA FLOWS UNDER ITER ELM RELEVANT CONDITIONS

Structure, substructure and stress parameters both on the surface and distributed by depth in the tungsten/steel coatings exposed to high energy hydrogen plasma fluxes were studied by X-ray diffraction methods. The hydrogen plasma exposure results in the following recrystallization processes in the thin surface layer of the coating: appearing the texture axis [100] normal to the surface; increasing the coherence length from 60 nm in the initial state to 80 nm after the plasma exposure; completely annealed micro-strains; and dislocation density lowered twice in the exposed surface layer – all these facts confirm the thermal character of the hydrogen plasma influence. No structure variations were observed already at the depth near 1  $\mu\text{m}$  of the coating.

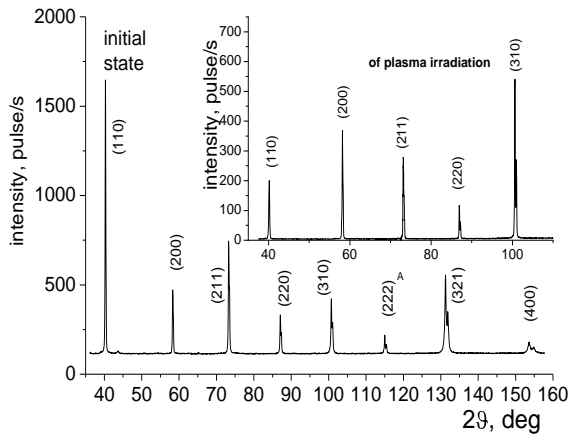
Fig. 1. X-ray diffraction patterns of a tungsten coating on steel in the initial state (below) and after plasma exposure (up)

The X-ray diffraction patterns are shown for the coatings in the initial state (below) and after plasma exposure (up) in Fig. 1. Texture was not observed in the coatings in the initial state. Non-uniform distributions of residual stresses and the lattice parameter  $a_0$  in the sub-surface layer were also determined (Figs. 2, 3). The maximum level of residual stress of 1.6 GPa was registered in the layer of 0.07  $\mu\text{m}$ , whereas 65 MPa was observed at the depth of 1  $\mu\text{m}$ . The maximum lattice parameter of  $a_0 = 0.31646 \text{ nm}$  was determined at the depth of near 1  $\mu\text{m}$  where the stresses were minimum. It should be noted, that the obtained lattice parameter corresponds to the reference value (0.3165 nm). Closer to the surface, the  $a_0$  parameter decreased to 0.31525 nm, the fact can be explained by excess point defects (vacancies) in the tungsten lattice.

Additionally, we observed the texture with axis [100] normal to the surface after plasma irradiation. The texture occurring indicates the recrystallization process in the surface layer of the affected material. It should be noted, that the diffraction maxima from the substrate material are absent in the diffraction pattern (see Fig. 1). This indicates that the thickness of the tungsten coating is still not less than 5  $\mu\text{m}$ .

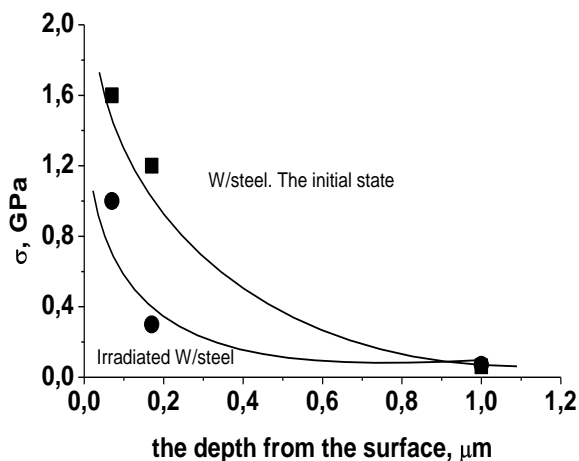
Fig. 2. Stress distribution over the depth of the W coating before and after hydrogen plasma exposure

After the hydrogen plasma loading, the surface stresses are annealed while being unchanged at the depth of the coating (see Fig. 2). The lattice parameter increases a little up to  $0.3160 \text{ nm}$  in the surface layer of  $0.2 \mu\text{m}$  (see Fig. 3). None of stress or lattice parameter variations were found at the depth of  $1 \mu\text{m}$ . However, closer to the surface, the lattice parameter increased due to vacancy annealing in the near surface layer.

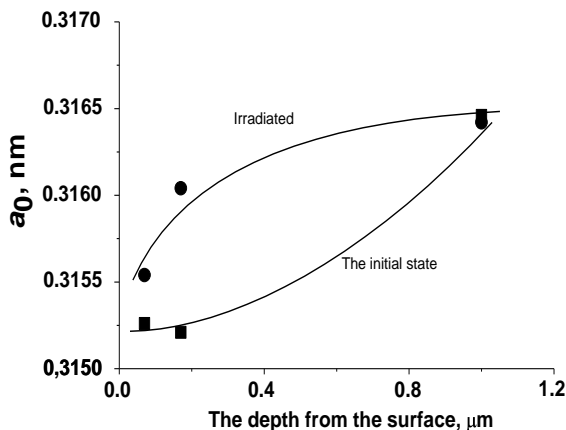
Fig. 3. Distribution of the lattice parameter over the depth of the W coating in the initial state and after hydrogen plasma exposure
